MAKING THE GRADE

How we are providing rapid and reliable fire detection in a quarry grading facility.

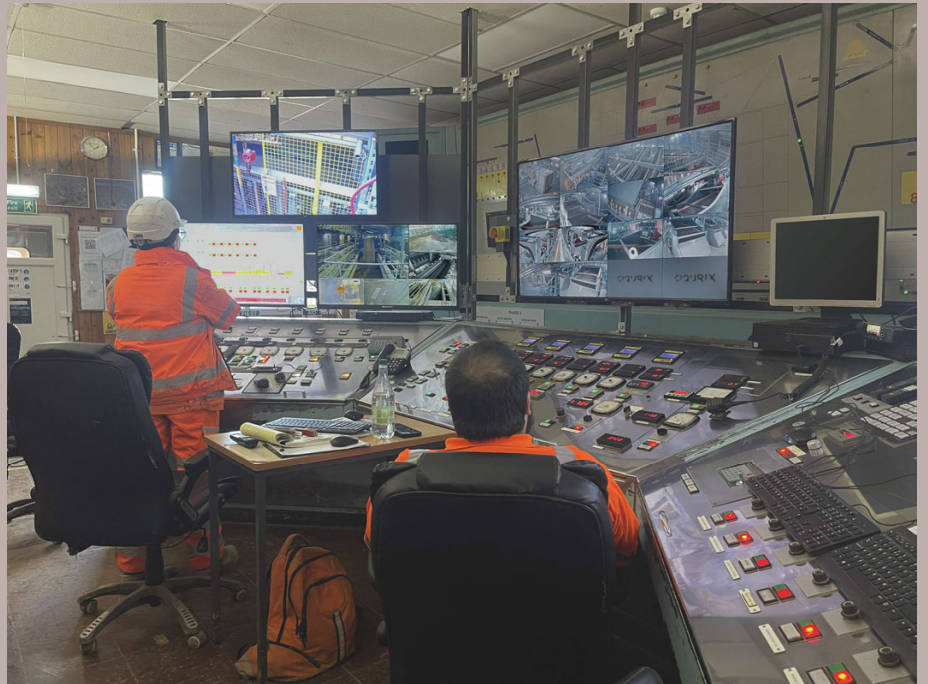
Site control room showing live feeds from Ciqurix video detectors.

The electrical engineering consultants responsible for the project evaluated numerous detection technologies before proposing the Ciqurix CORE video flame detection system. The site insurer was not familiar with the technology so they conducted their own due diligence and evaluation process before accepting the proposal. The CORE system consists of 14 video flame detectors and 3 control hubs, positioned to cover open areas and areas of risk. Comprehensive 3D modelling was used to predict coverage and establish the most effective mounting locations. The CORE system is linked directly into the site fire system to provide zoned fire and fault notification, and also provides a live video feed from each detector into the site control room.
